PIKES CREEK DAM

NDS ID NO. PA-00576

PHASE I INSPECTION REPORT
NATIONAL DAM INSPECTION PROGRAM

JULY 1978

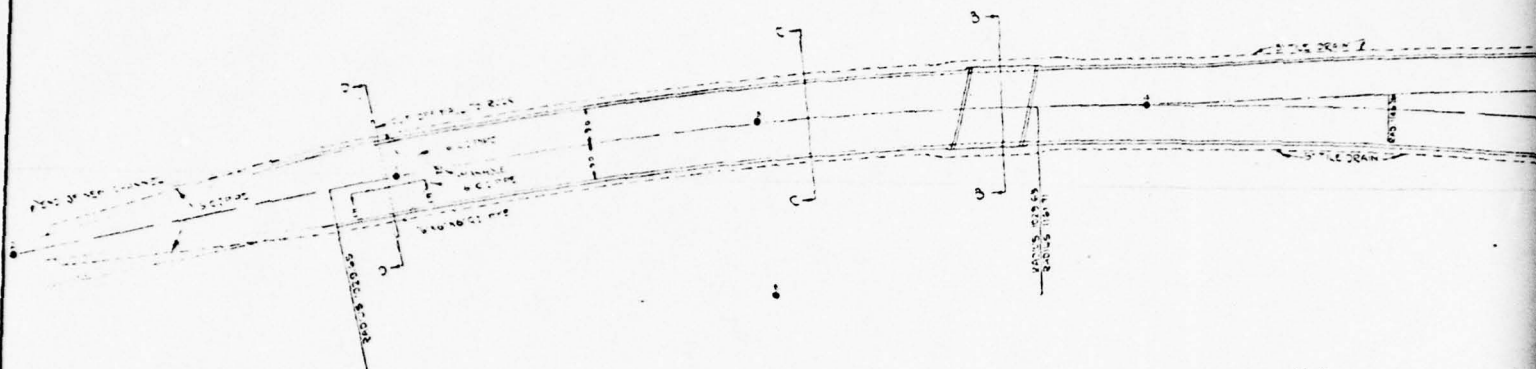
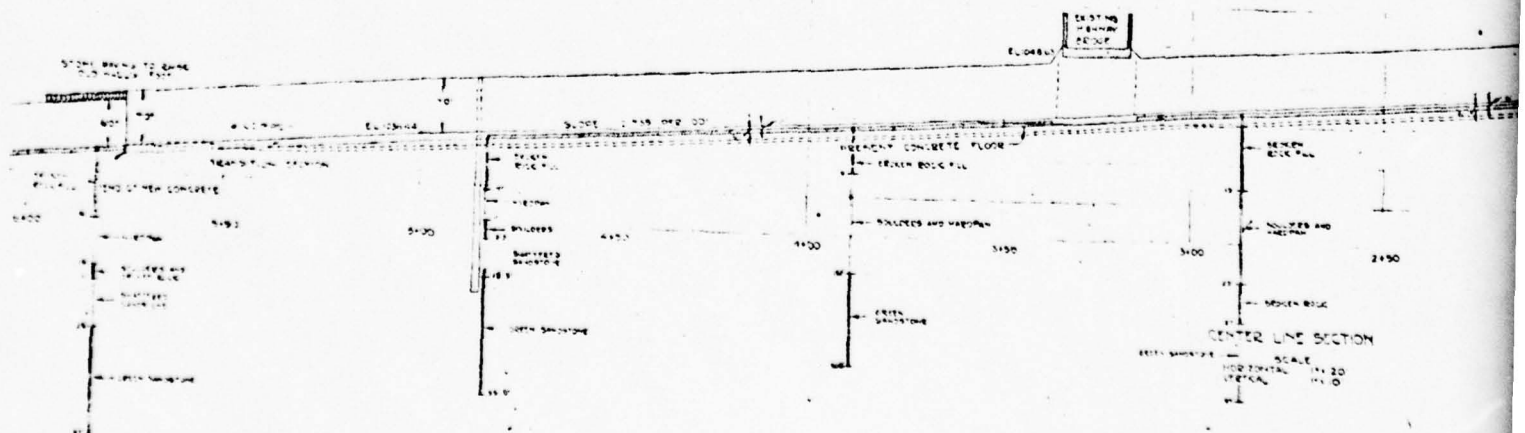
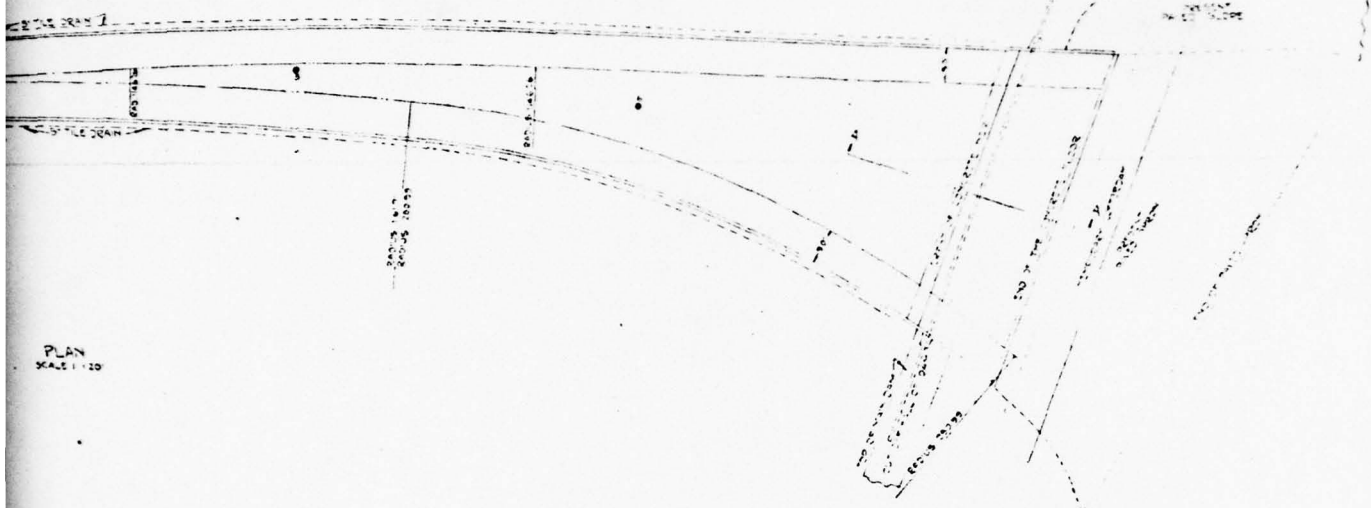
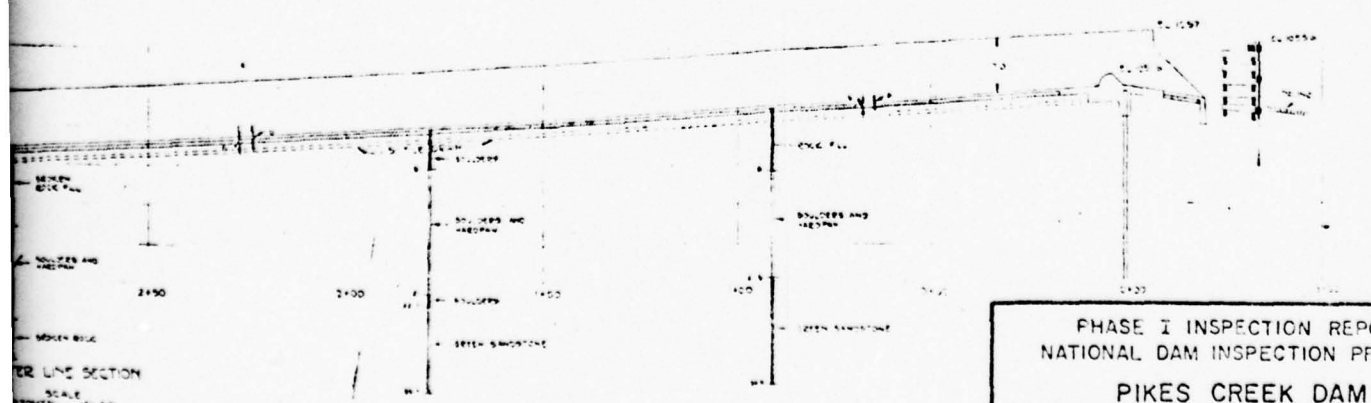
PHASE I INSPECTION REPORT
 NATIONAL DAM INSPECTION PROGRAM
 PIKES CREEK DAM
 PENNSYLVANIA GAS AND WATER COMPANY
 SPILLWAY-PLAN AND PROFILE
 JULY 1978
 PLATE 3

The existing main spillway weir crest is 1.6 feet above the upstream and downstream channel. During a review of the spillway section (Plate 3), it was estimated that the structure would be stable for the expected loads. Stability analyses on structures this small are usually not performed.
